AIRCRAFT ACCIDENT REPORT

**PACIFIC SOUTHWEST AIRLINES, INC.,
B-727, N533PS AND**

**GIBBS FLITE CENTER, INC.,
CESSNA 172, N7711G**

**SAN DIEGO, CALIFORNIA
SEPTEMBER 25, 1978**

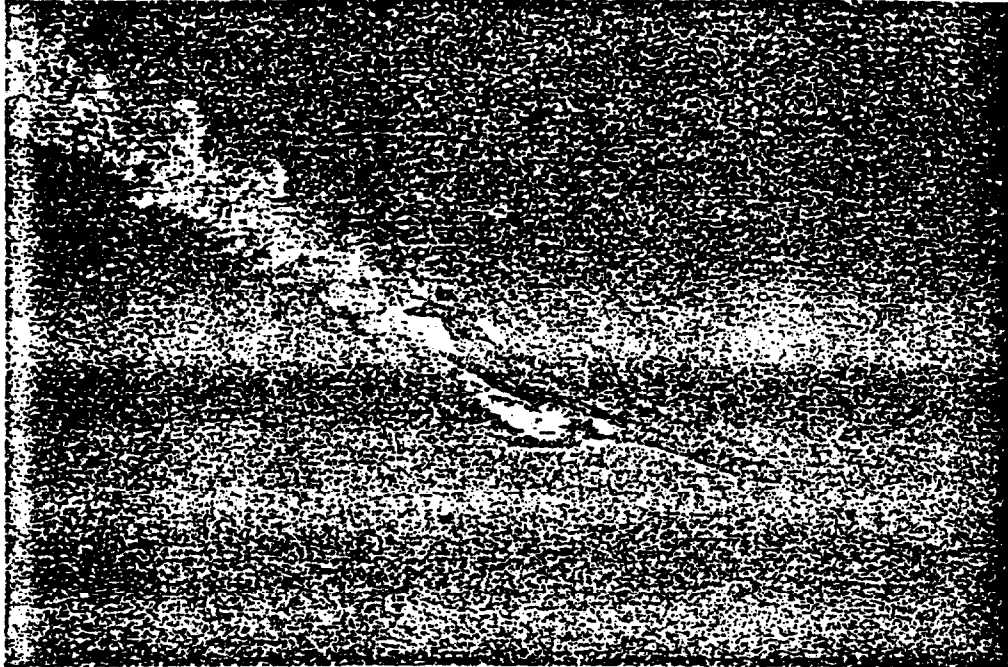
Enlargements of two postcollision photographs were used to try to determine the Boeing 727's flight control displacements and the condition of its fuel and hydraulic systems during the latter portions of the flight. (See Figures 1 and 2.)

Except for the upper and lower rudders, which were centered in the first photograph and positioned 10° left in the second, the deflections of the other control surfaces in both pictures were the same. The left wing flight spoilers were full up; the left wing ailerons were full up; the right wing outboard aileron was down; the elevators were almost full up; the trailing edge flaps were extended to 15°; and the leading edge devices were extended fully.

Figure 1. Flight 182 after colliding with the Cessna.
